Tinkers Creek Steam Restoration and Slope Stabilization Valley View, Ohio

Tinkers Creek and a severely eroding slope threatened critical dual FirstEnergy power transmission lines. URS provided multidisciplinary services including survey, geotechnical, geomorphology, landscape architectural, hydrological, permitting, and construction administration for the restoration of 1,000 lineal feet of a 100' wide stream and stabilization of a 100' height slope on Tinkers Creek in Valley View, Ohio.

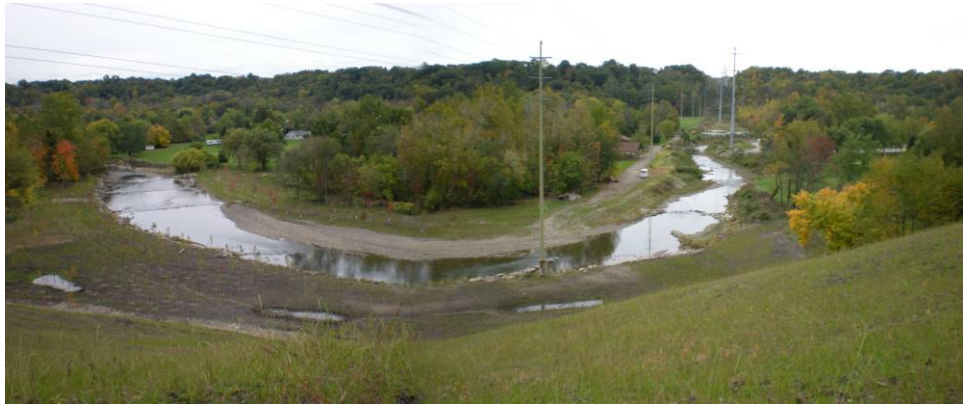
Stabilization of the 100' height slope is being accomplished by reconstruction from the toe up, needing more than 40,000 CY of fill. The completed slope at a 2.5:1 includes a drainage blanket for ground water and a naturally stabilized slope with compost and plantings.

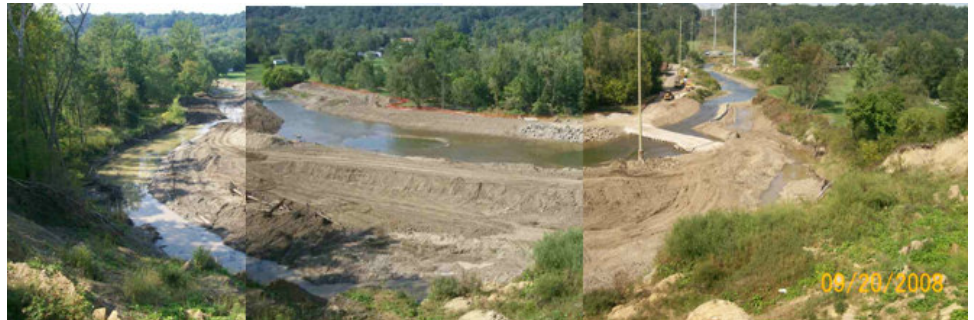
Relocated to its location in the 1970's, the stream moved more than 300' from its position at the beginning of the project (see below construction photo). Native floodplain vegetation including trees and whip plantings are beginning to establish.

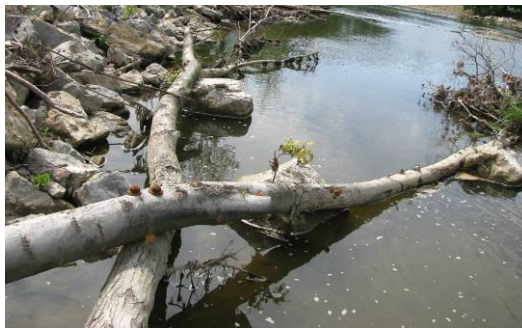
In stream log structures were imbedded into the shoreline to increase fish habitat, provide roughens in the stream, and armors channel.

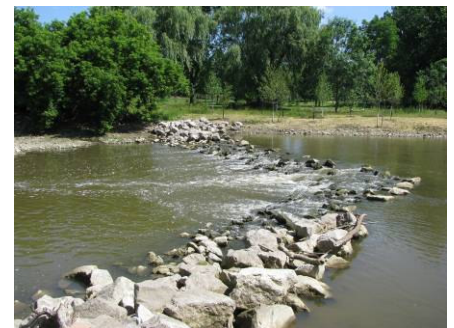
The relocated stream and constructed rock vanes channel water towards the center of the stream, reducing erosion.
